IN THE UNITED STATES DISTRICT COURT
FOR THE WESTERN DISTRICT OF TEXAS
SAN ANTONIO DIVISION

CIVIL ACTION NO. 5:15-cv-000425-DAE

AFFIDAVIT OF RICHARD V. BARATTA, Ph.D., P.E.

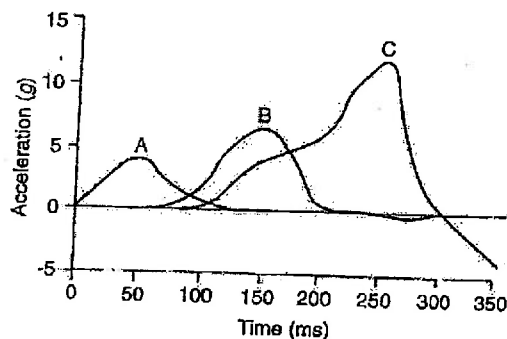
Figure 8.20 Idealized acceleration curves of (A) an impacted vehicle, (B) an occupant's shoulders, and (C) an occupant's head. As the vehicle is impacted (e.g., in an automobile rear-end collision), it accelerates first, reaching a peak acceleration of almost 5 g's (i.e., five times the acceleration of gravity). The vehicle occupant's shoulders reach their peak acceleration of about 7 g's 100 ms later. Finally, the occupant's head reaches its peak acceleration of greater than 12 g's 250 ms after initial impact. This sequential progression of peak accelerations is evidence of both momentum and energy transfers.

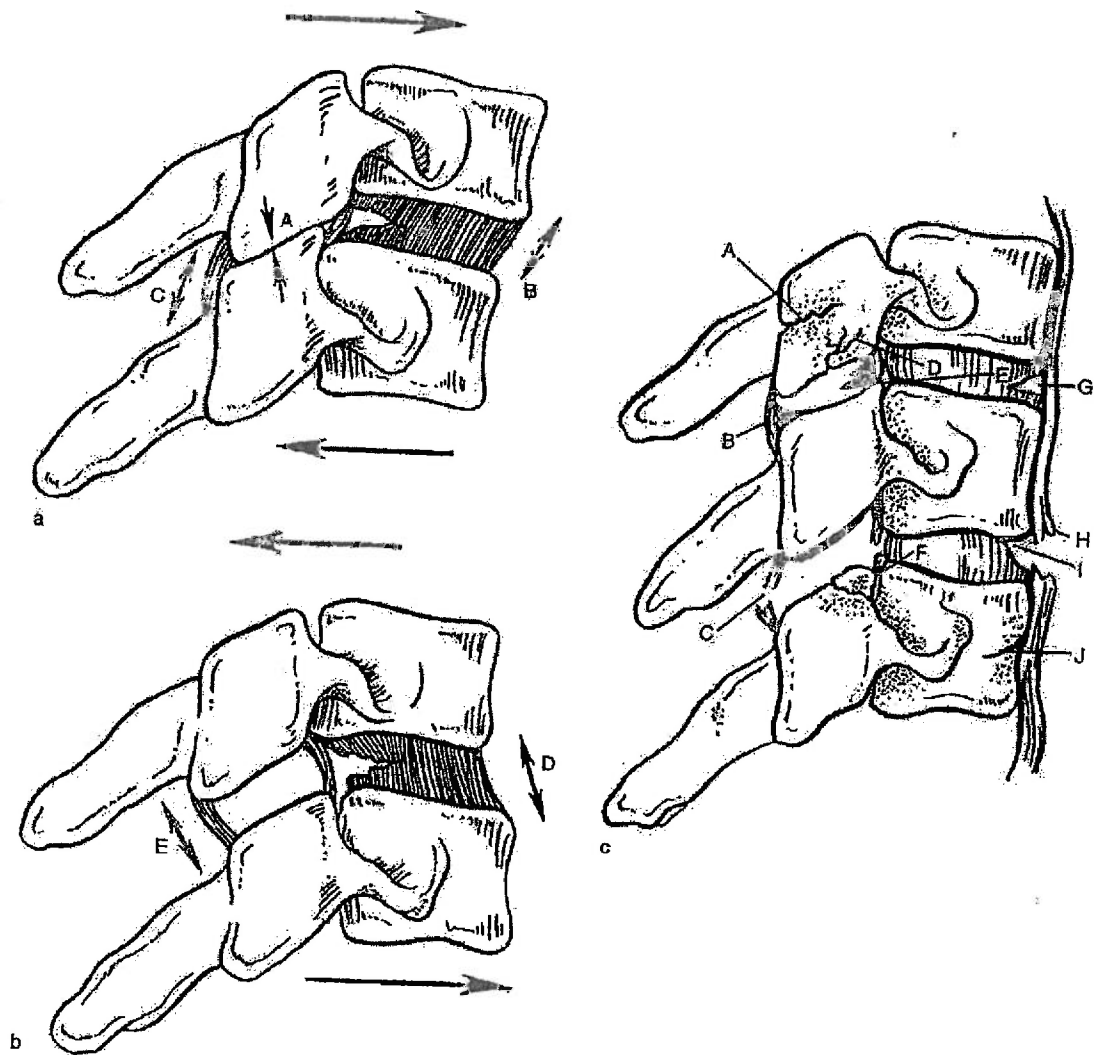
Figure 8.21 Shear forces affecting a spinal motion segment. (a) Translation of the superior vertebral body anteriorly relative to the inferior body. This movement stresses the articular surfaces of the zygapophyseal joints (A), the anterior annulus fibrosus (B), and the zygapophyseal joint capsule (C). (b) Translation of the superior vertebral body posteriorly relative to the inferior body, which stresses the intervertebral disk (D) and the zygapophyseal joint capsules (E). (c) Common lesions affecting the cervical spine following whiplash injury. A, articular pillar fracture; B, hemarthrosis (hemorrhage into a joint) of the zygapophyseal joint; C, rupture or tear of the zygapophyseal joint capsule; D, fracture of the subchondral plate; E, contusion of the intraarticular meniscus of the zygapophyseal joint; F, fracture involving the articular surface; G, tear of the annulus fibrosus; H, tear of the anterior longitudinal ligament; I, end-plate avulsion fracture; J, vertebral body fracture.

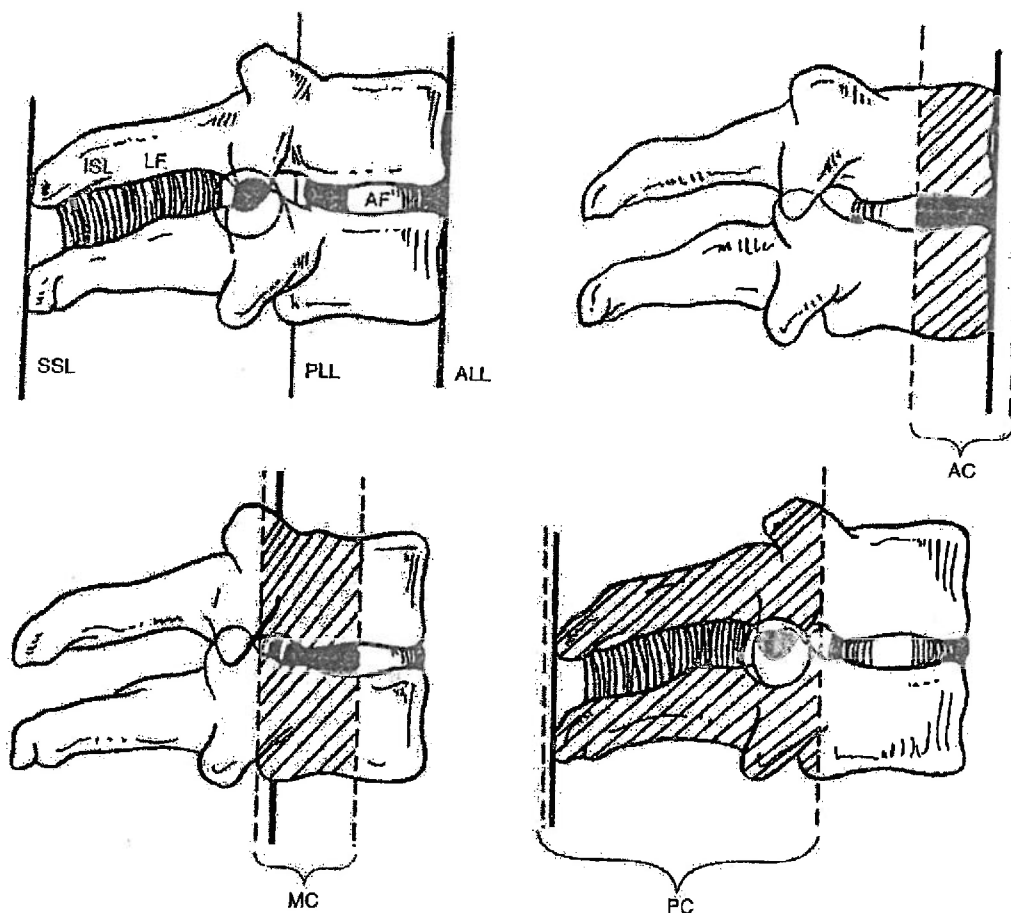
Figure 8.23 Three-column model of the spine: AC, anterior column (*upper right*); MC, middle column (*lower left*); PC, posterior column (*lower right*). Vertebral structures: SSL, supraspinous ligament; PLL, posterior longitudinal ligament; ALL, anterior longitudinal ligament; AF, annulus fibrosus; LF, ligamentum flavum; ISL, interspinous ligament. From "The three column spine and its significance in the classification of acute thoracolumbar spinal injuries" by F. Denis, 1983, *Spine*, 8(2), (Fig. 1, p. 818). Copyright 1983 by J.B. Lippincott Company. Reprinted by permission.

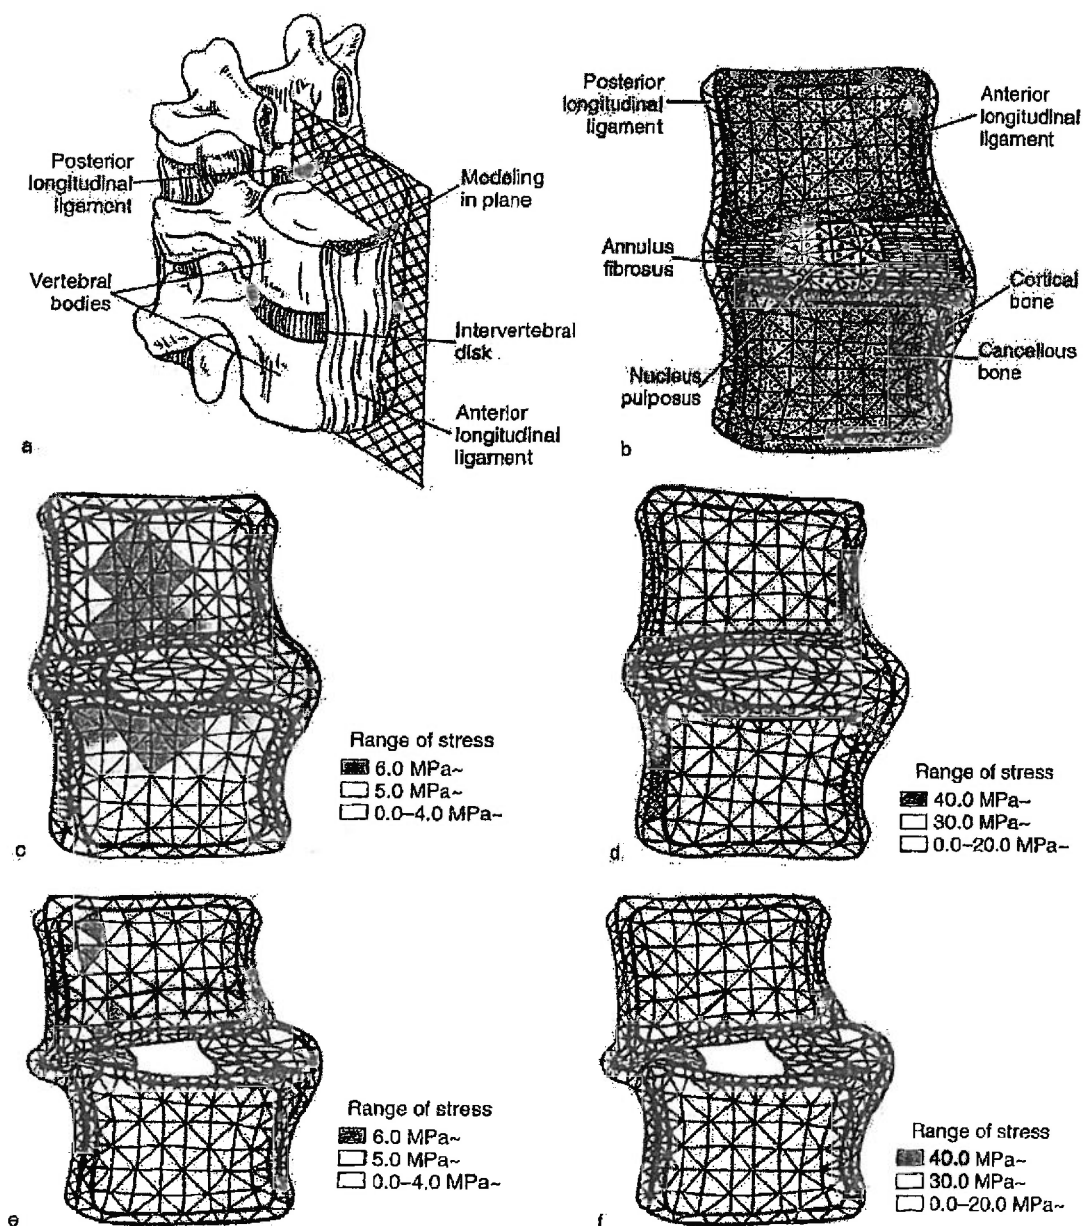
Figure 8.24 (a) Median (midsagittal) plane of modeling. (b) Finite-element plane model. (c) Stress distribution of one motion segment with a healthy disk under axial compression showing highest trabecular bone stresses under the nucleus pulposus and at the superoposterior regions, and (d) highest cortical shell stresses at the middle of the end plate and posterior wall cortex. (e) Stress distribution in a model of a severely degenerated disk shows no stresses in the trabecular bone under the nucleus, and (f) highest stresses in the cortical bone of posterior wall.

The degree of disk degeneration confounds the mechanism of burst fracture. A finite-element computer model (figure 8.24; Shirado et al. 1992) showed that in motion segments with normal disks, the highest stresses were found under the nucleus and at the superoposterior portions of the trabecular body. In a severely degenerated disk, no stresses were seen under the nucleus and little stress at the middle of the end plate. Based on the computer model of thoracolumbar loading, the researchers concluded that with healthy disks, rapid axial compressive loading induces a burst fracture with bone fragments retropulsed into the spinal canal. In people with severely degenerated disks (e.g., elderly with osteoporosis), burst fractures would be much less likely and, should they occur, would involve the anterior column and thus not have associated neurological deficits (Shirado et al. 1992).

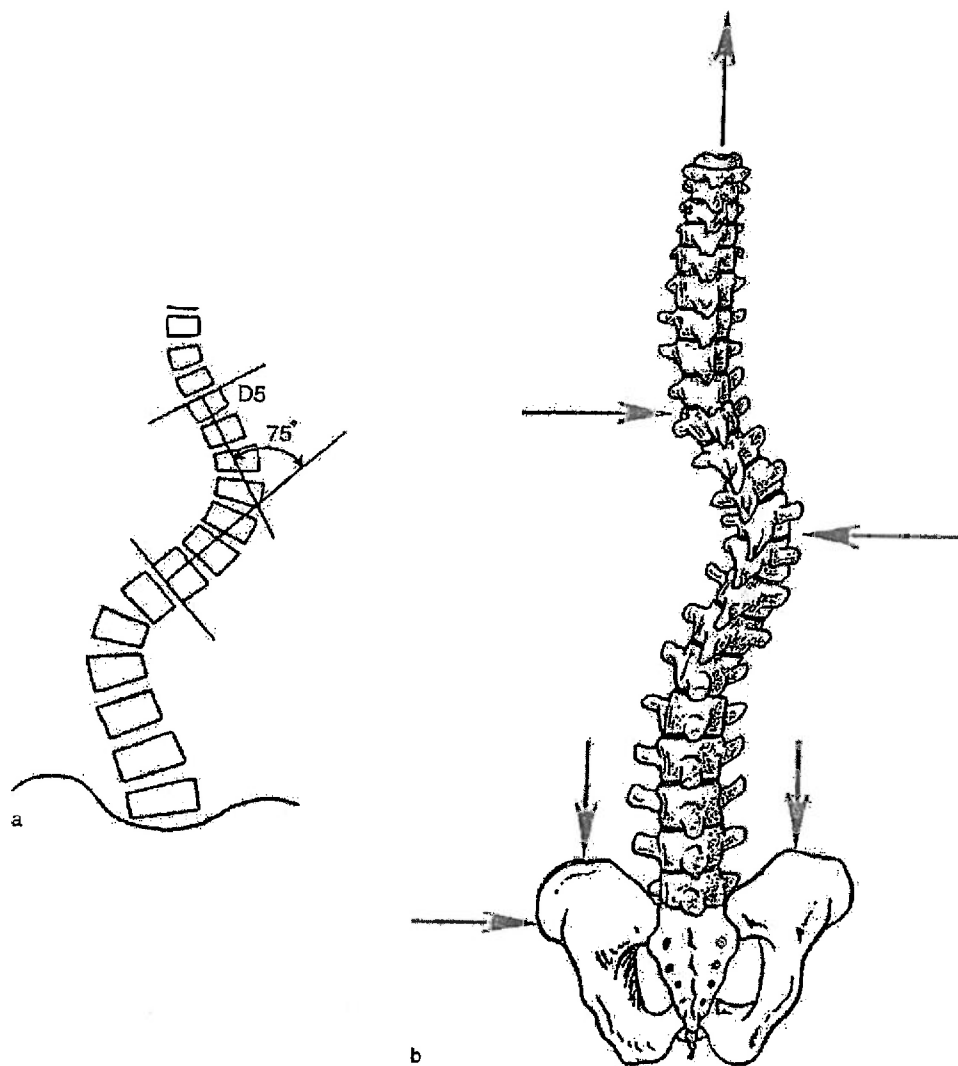
Figure 8.25 (a) Cobb's angle, defined as the angle (75° in the example shown here from Cobb's work) between the two lines that perpendicularly bisect the lines through the surfaces of the vertebrae at each end of the curvature. (b) Free-body diagram of the forces exerted on the spine by a brace to correct scoliosis deformity.

Scoliosis is defined as a lateral (frontal plane) curvature of the spine, which is also usually associated with a twisting of the spine (figure 8.25a). Mild spinal deviations are well tolerated and usually are asymptomatic. Severe deformities, in contrast, can markedly compromise cardiopulmonary processes. Scoliotic curvatures exceeding 90° greatly increase the risk of cardiorespiratory failure through the cumulative effect of decreased lung and chest wall compliance, poor blood oxygenation (hypoxemia), increased work of breathing, reduced respiratory drive, enlarged heart (cardiomegaly), and pulmonary arterial hypertension (Padman 1995).

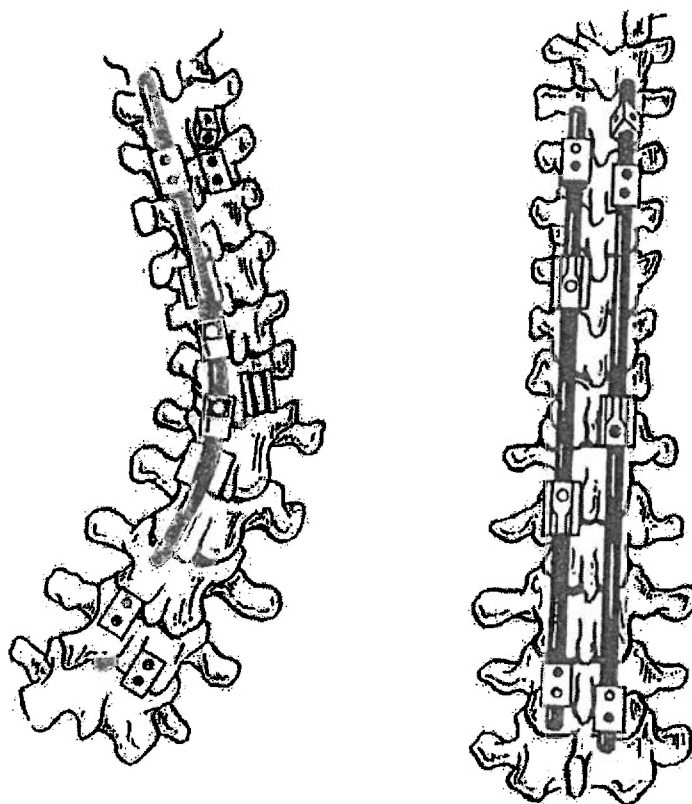
Figure 8.26 Variations of Harrington instrumentation used to correct spinal deformities.

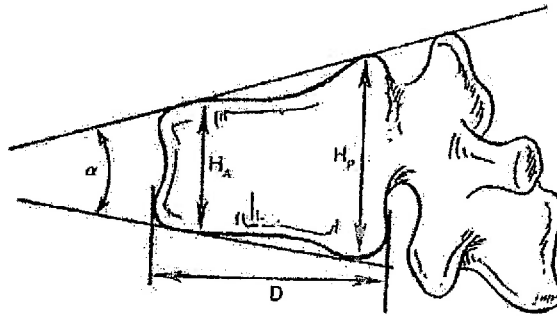
Figure 8.27 Vertebral wedging as measured by the angle α . The amount of wedging can also be measured by calculating the body height ratio (H_A/H_P).

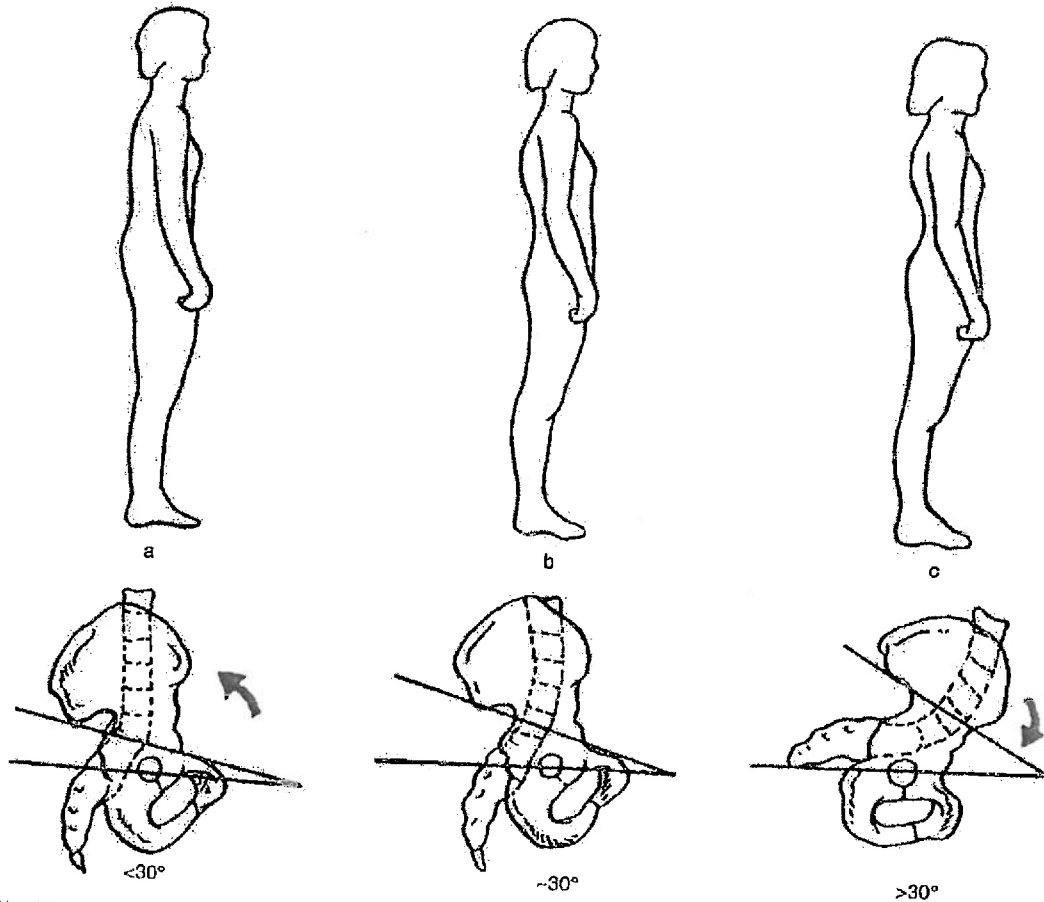
Figure 8.28 Effect of pelvic tilting on the lumbosacral (L5-S1) angle. (b) Normal standing creates a lumbosacral angle of approximately 30° . (a) Tilting the pelvis backward decreases the lumbosacral angle ($< 30^\circ$) and flattens the lumbar spine. (c) Tilting the pelvis forward increases the lumbosacral angle ($> 30^\circ$) and exaggerates the lumbar lordosis. Reprinted from Lindh 1989.

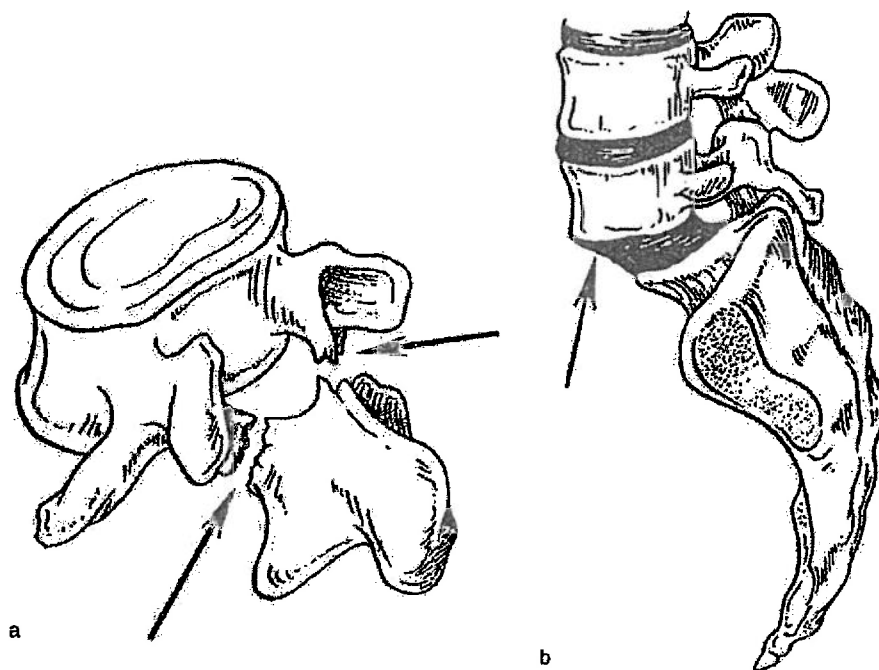
Figure 8.29 (a) Spondylolysis showing bilateral fracture of the pars interarticularis (arrows). (b) Spondylolisthesis exhibiting slippage (arrow) between the L5 and S1 vertebrae.

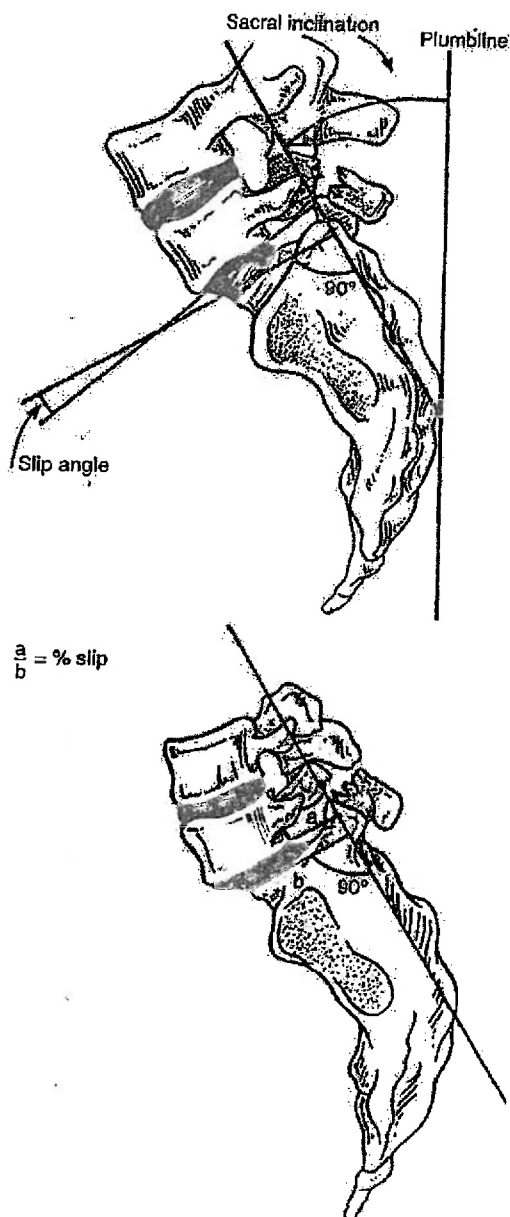
Figure 8.30 Schematic of sacral inclination and slip angle (*top*) and percentage slip (*bottom*). Adapted from Stinson 1993.

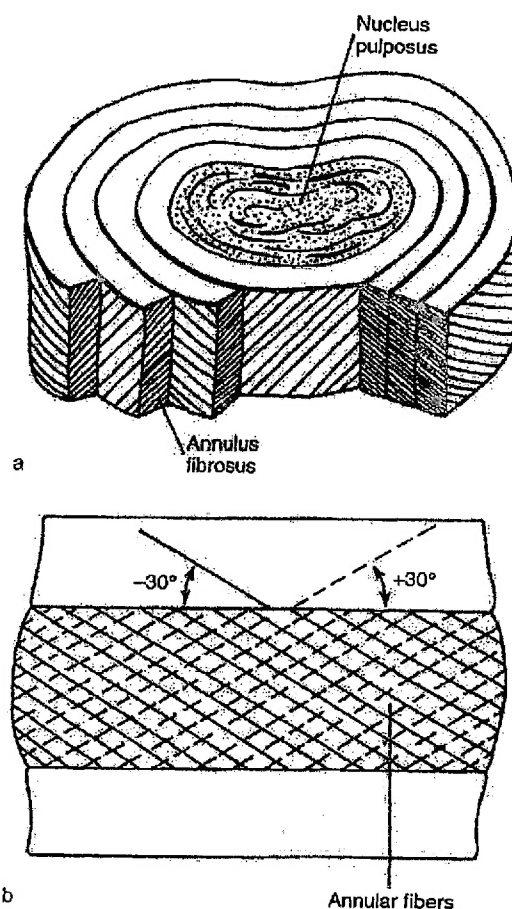
Figure 8.31 (a) Concentric rings of the annulus fibrosus surrounding the centrally located nucleus pulposus. (b) Alternating 30° angulation of annular fibers. This structural orientation enhances the ability of the annulus fibrosus to accommodate multidirectional loading.

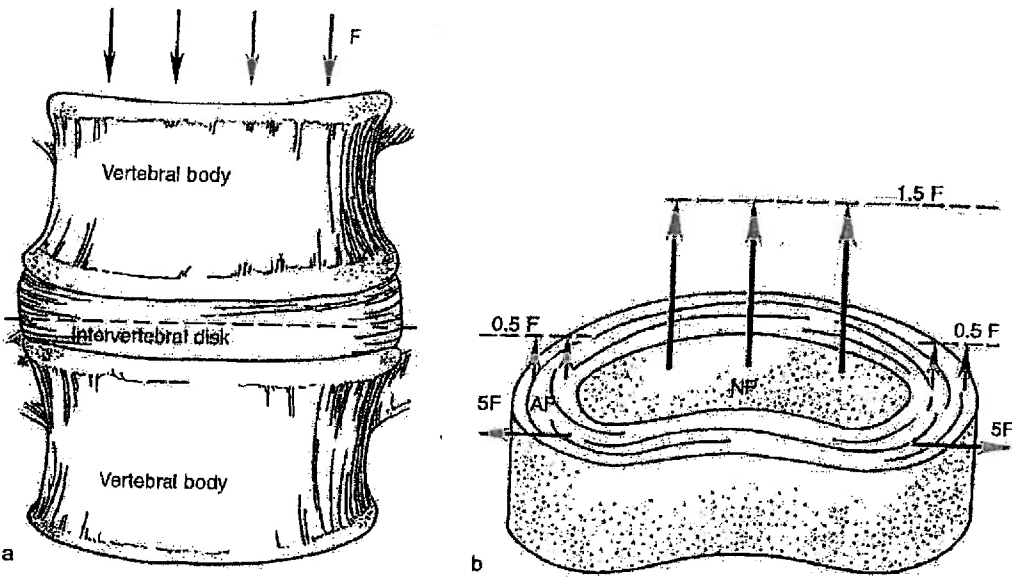
Figure 8.32 Uneven stress distribution across the lumbar intervertebral disk. A uniform compressive load (F) applied through the vertebral body (a) creates an axial stress of $1.5 F$ (per unit area) in the nucleus pulposus (NP) (b). The annulus fibrosus (AF), in contrast, generates an axial stress of only $0.5 F$. The orthogonal stress in the annulus (perpendicular to the applied load) can reach levels up to five times the applied force ($5F$). Reprinted from Nachemson 1975.

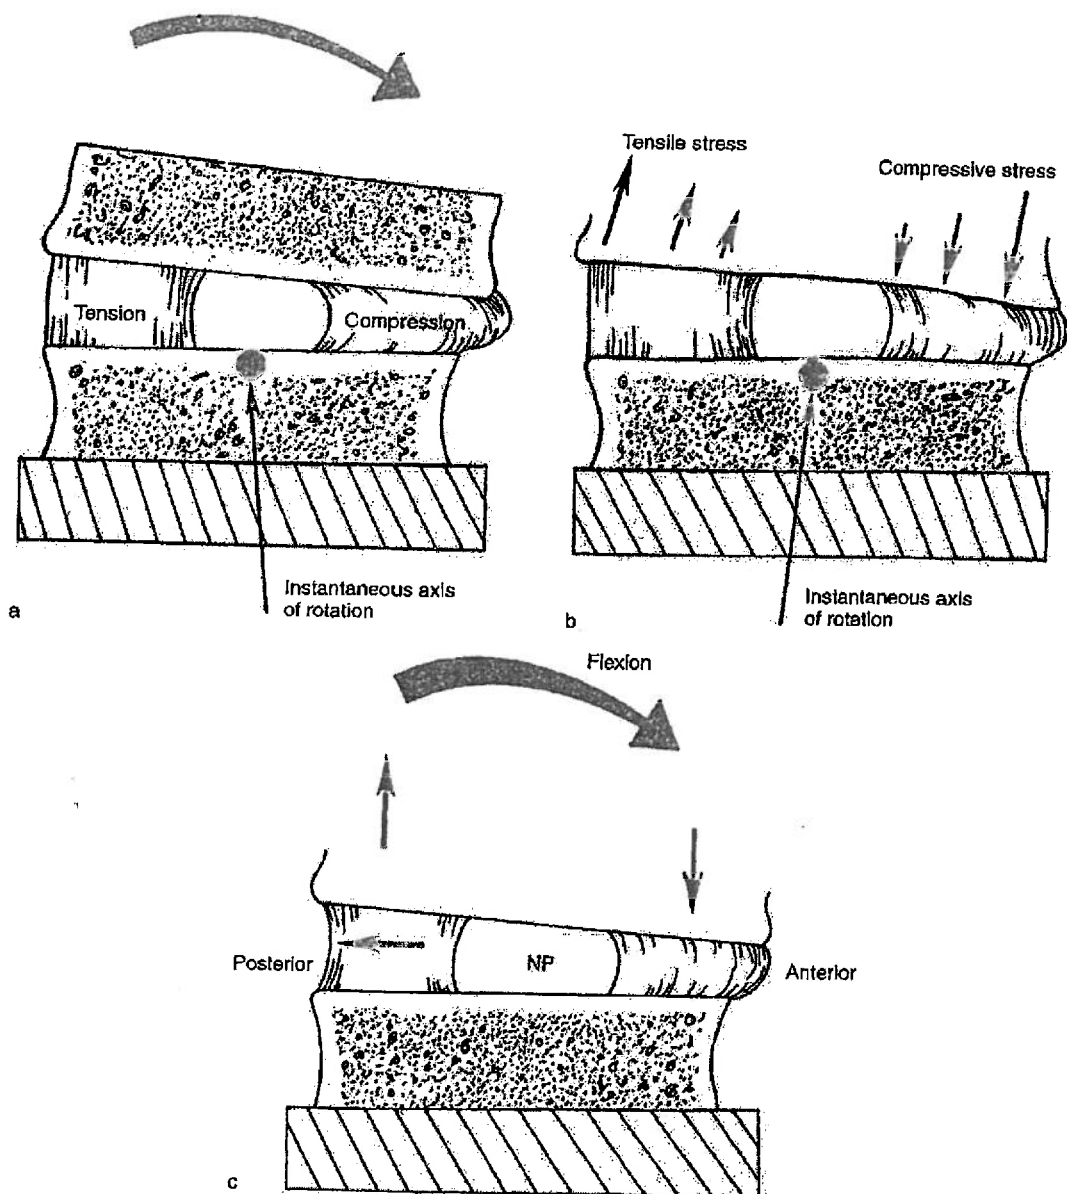
Figure 8.33 Intervertebral disk stress in response to bending. (a) In bending, one side of the disk experiences compression while the other side undergoes tension. (b) The compressive and tensile stresses are at a maximum at the outer borders of the disk and decrease toward the center of the disk. (c) Forward flexion of the spine tends to squeeze the nucleus pulposus (NP) posteriorly.

ing. This mechanism creates tensile stresses on the posterolateral aspect of the annulus fibrosus (figure 8.33), which, when combined with a compressive load, results in disk prolapse. Adams and Hutton (1982) suggested that sudden disk prolapse occurs

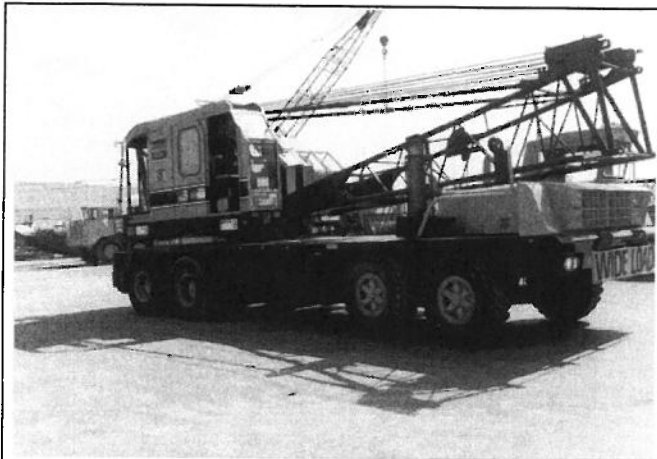
Figure 1 - The truck crane or striking vehicle

VEHICLES - For this testing, the same two vehicles were used for a pair of tests. The striking vehicle was a 1982 American Model 5470 Truck Crane. The crane had two front and two rear axles, and its chassis supported an operator house and the first section of crane boom. Near the middle of the crane and at its rear were extendable hydraulic support legs for stabilizing it during operation. At the front left of the crane truck chassis was the driver's compartment. Both front axles of the crane truck were steerable, and its unloaded vehicle weight was about 21,000 kilograms.

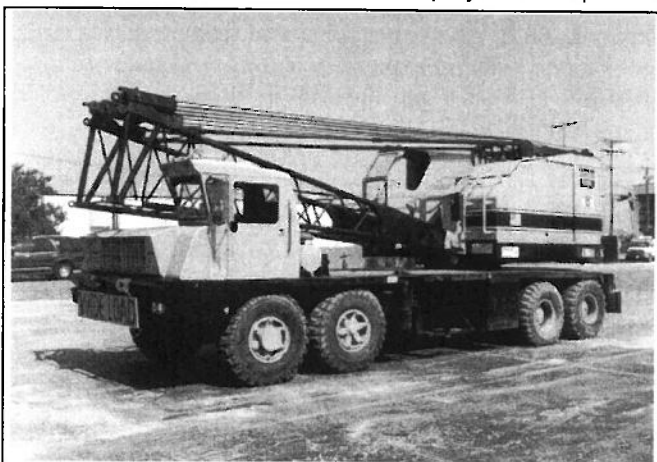
Figure 2 - Alternate view, the left side of the truck crane

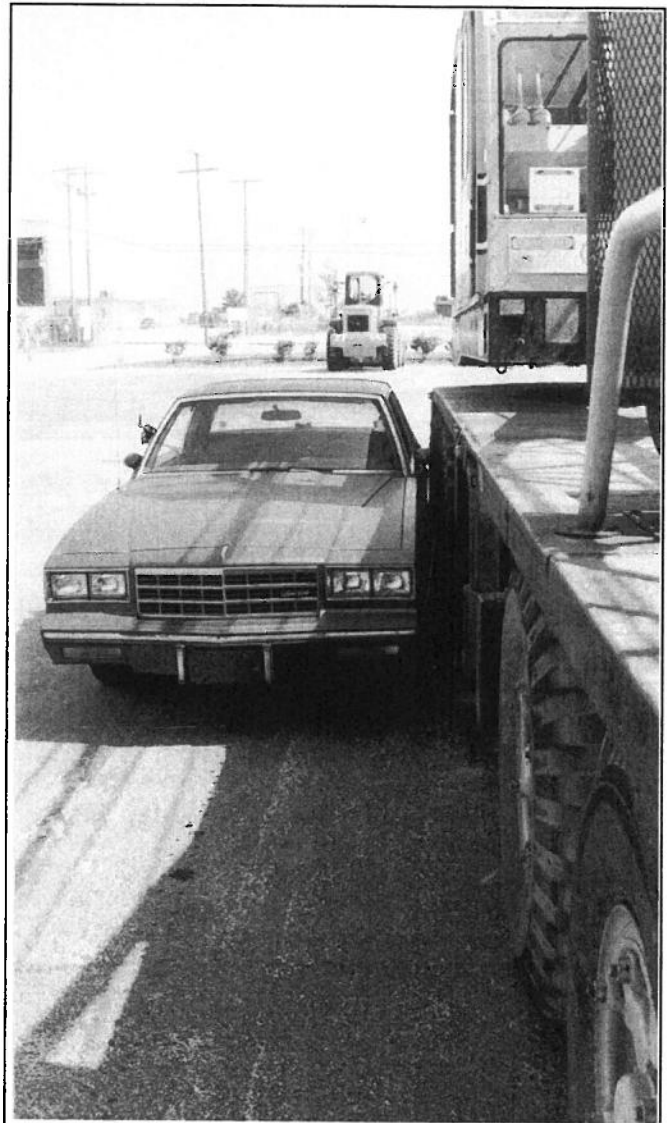
Figure 3 - The 1983 Monte Carlo next to the truck

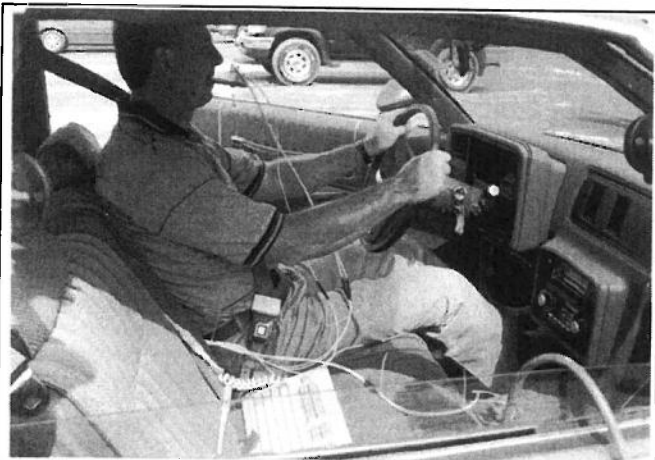
Figure 4 - The instrumentation of the car and driver

The same was not true for the Chevrolet. Both the car and its driver were fitted with triaxial accelerometers. In the case of the car these were rigidly mounted to the floor near the vehicle's center of gravity. The accelerometers were fitted to the driver by use of a biteplate that could be rigidly clenched between his teeth. Thus, the biteplate would undergo the same general motion as the skull. The instrumentation in the car is shown in Figure 4. The triaxial accelerometer block was mounted in the vehicle so that the x-direction was in the positive forward direction, the y-direction was positive to

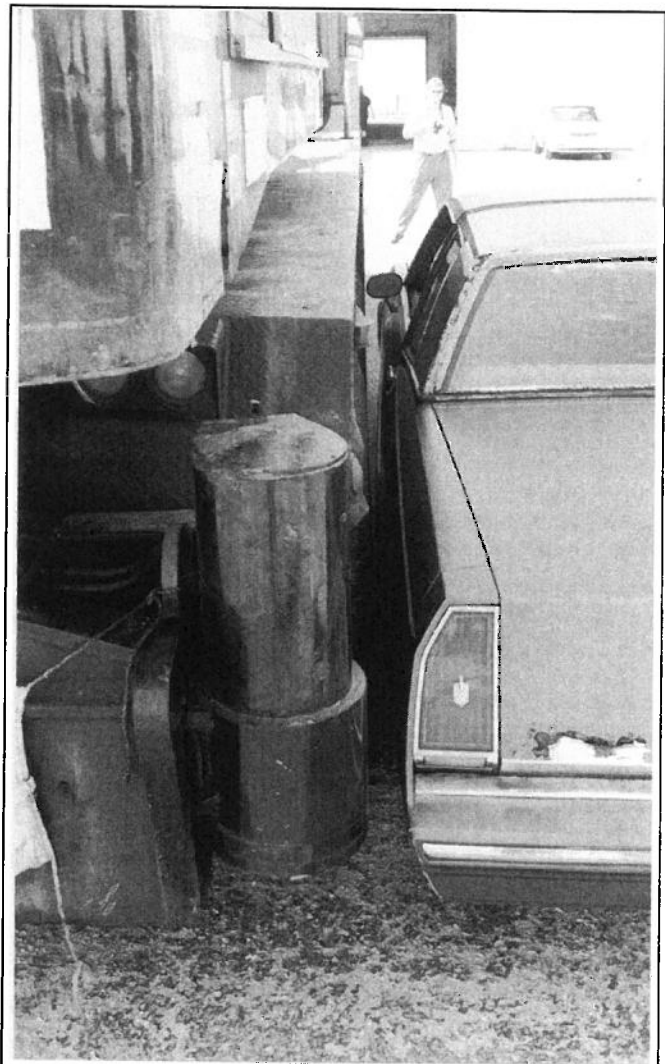
Figure 5 - The target position for the truck driver to begin steering right

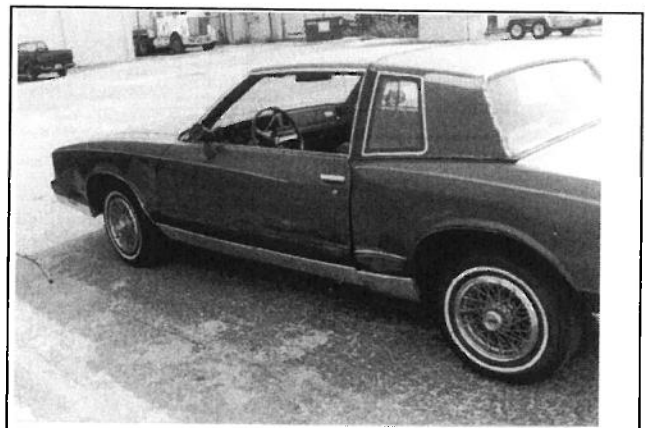
Figure 14 - Test 2 damage to the driver's side of the car

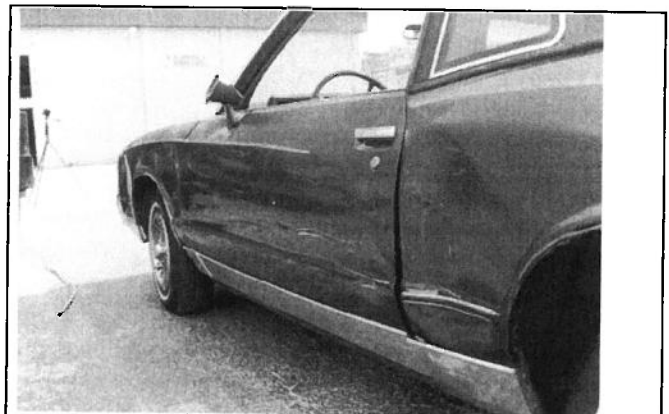
Figure 15 - Another view of the damage from test 2

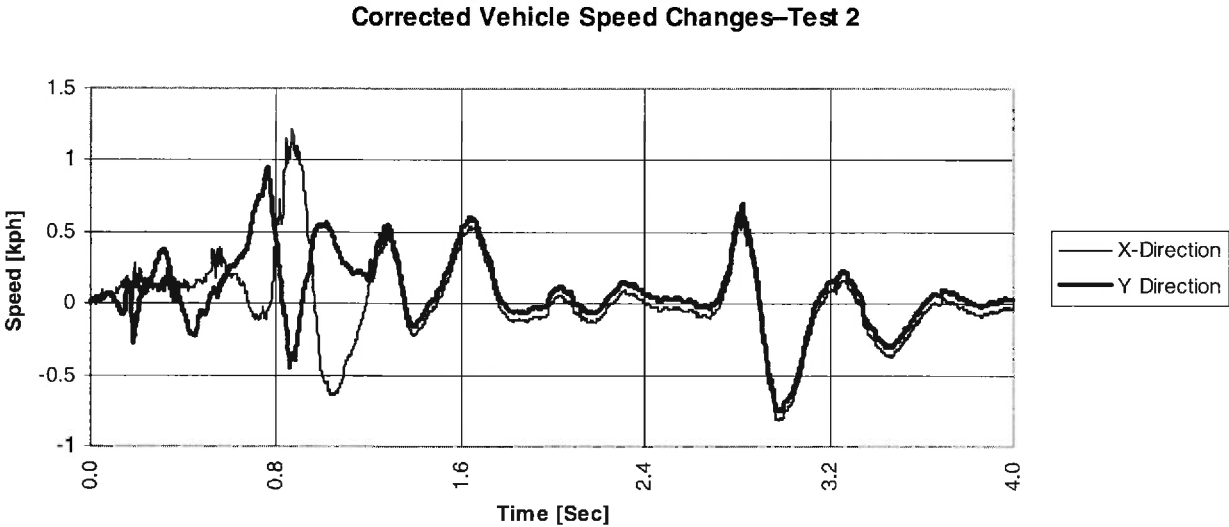
Figure 25—Test 2 Vehicle Speed Change after Vehicle Pitch and Roll Corrections

and velocity curves. This is done by identifying the portion of the acceleration curves that correspond to contact between the vehicles. Once the time window of the contact is determined, the necessary average offset in the acceleration to cause the indicated speed change can be estimated. This value is then subtracted from the acceleration signal and the signal is integrated. This process is repeated until the known velocity condition of the vehicle at the end of the signal (in this case, zero) is reached. The corrected curves for the y axis vehicle accelerations are given in Figures 21 and 24 for tests one and two, while the corrected curve for the x axis acceleration in the second test is given in Figure 23. Because of the minimal vehicle pitching in the first test, it was felt no correction was necessary for the x axis data in that test. In addition, the vehicle was rolling with some unknown speed when the data signal stopped, so application of the method would not have been feasible. The corrected vehicle speed change curves are given in Figures 22 and 25.

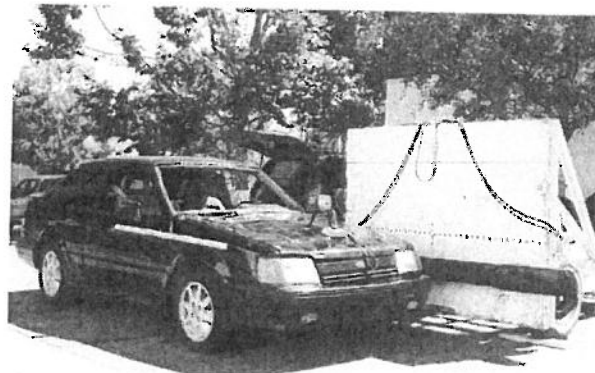
Figure 1 - Barrier/vehicle exemplar orientation

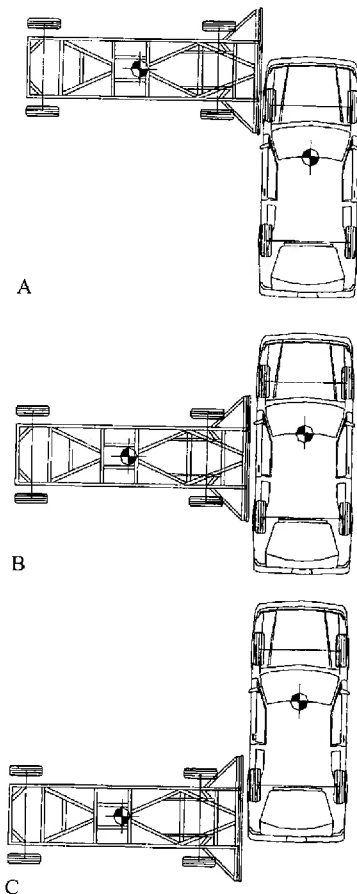
Figure 2 - Barrier/vehicle impact orientation to (A) front, (B) door area/middle and (C) rear

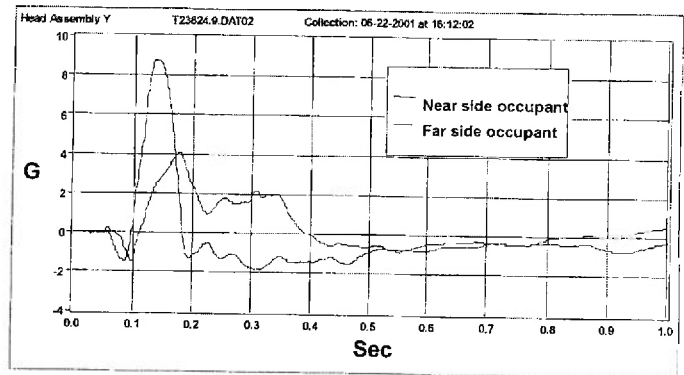
Figure 3 - Head acceleration comparison of near side to far side occupant for a driver's side impact

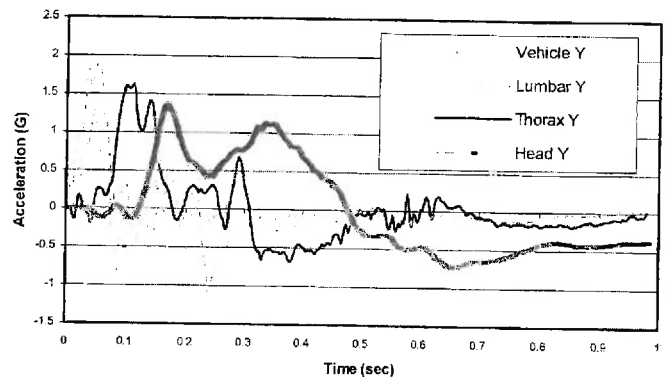
Figure 4 - Comparison of acceleration profiles for the lumbar, thoracic and head mounted accelerometers

to head-to-head restraint contact. An example of this phenomenon is shown in Figure 4.

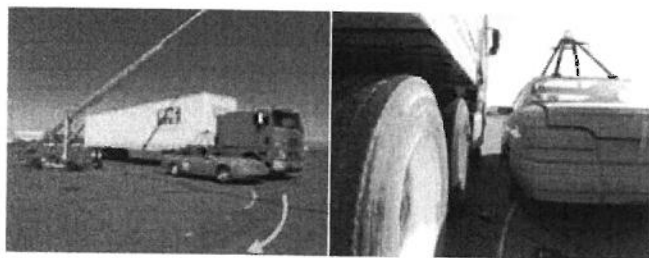
Figure 1. Sideswipe pre-test configuration (Test 1A). Orange arrow shows direction of sedan movement as it is pulled forward/laterally by turning semitrailer.

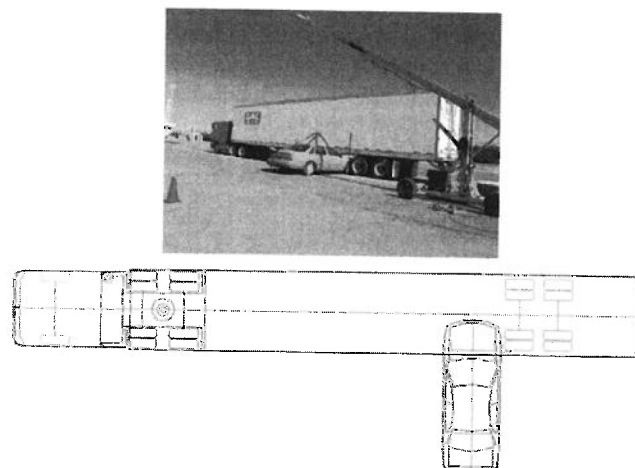
Figure 2. 90-degree collision pre-test configuration (Test 3). The speed of the tractor-semitrailer was 12 mph, and the speed of the sedan was 6 mph.

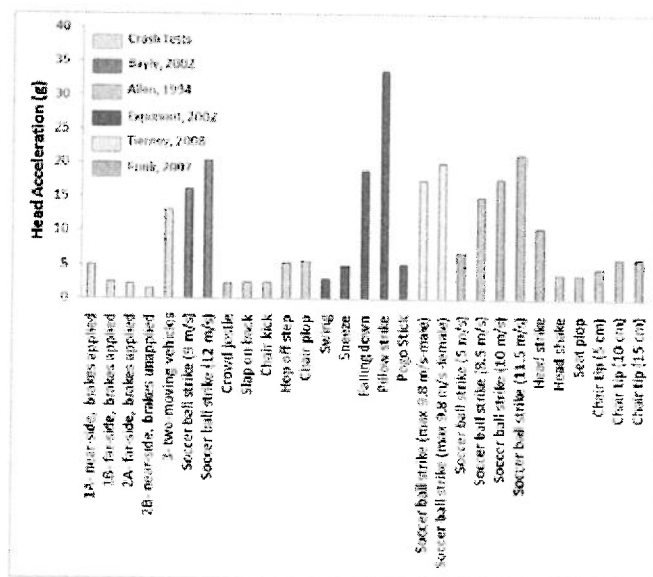
Figure 7. Peak linear head accelerations (g) for crash testing and various non-injurious activities.

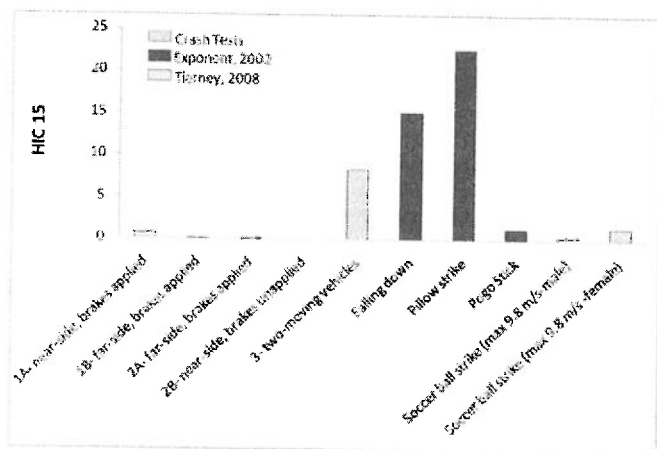
Figure 8. HIC for crash testing and various vigorous activities.

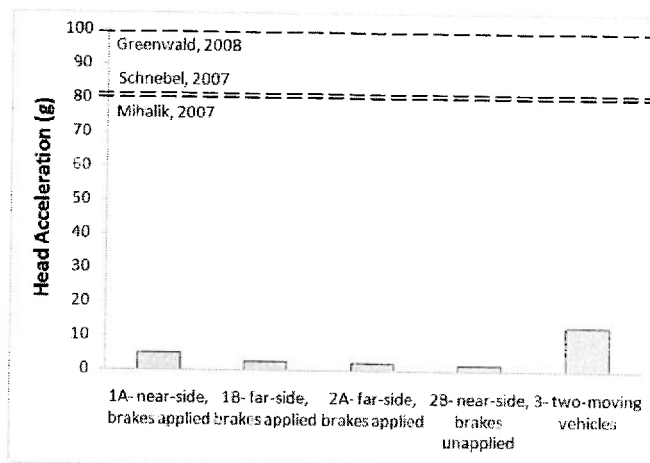
Figure 9. Peak linear head accelerations (g) for crash testing in relation to reported lower limits for concussion.

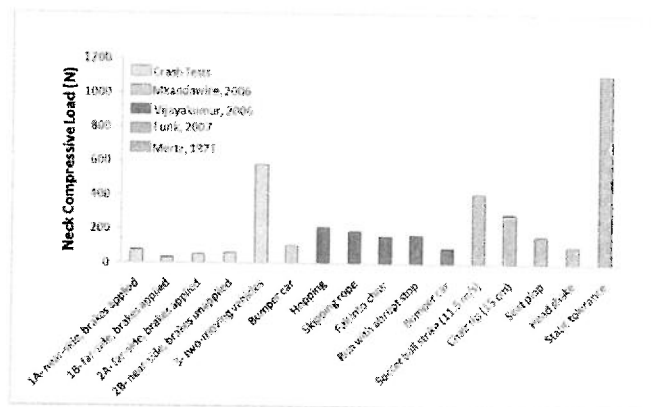
Figure 10. Peak upper neck compressive loads for crash testing and various non-injurious activities.

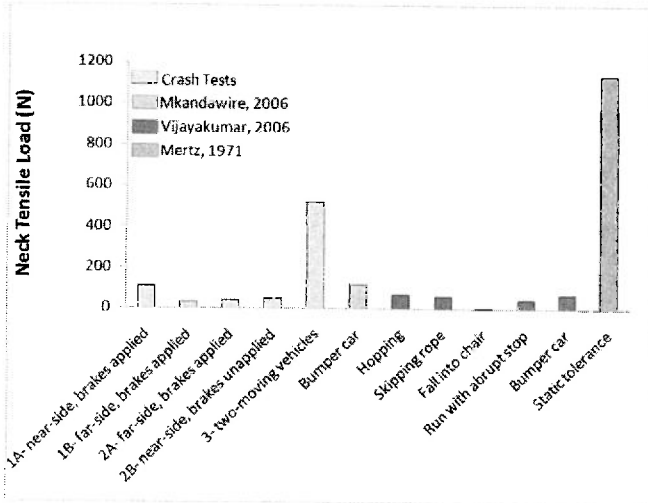
Figure 11. Peak upper neck tensile loads for crash testing and various non-injurious activities.

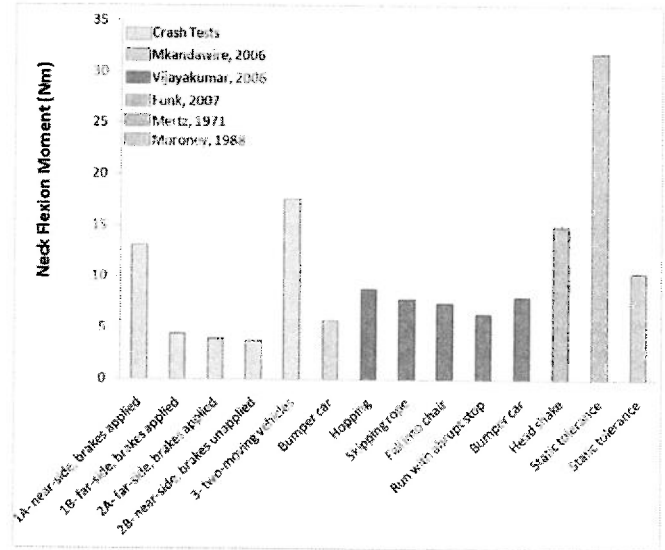
Figure 12. Peak upper neck flexion moments for crash testing and various non-injurious activities.

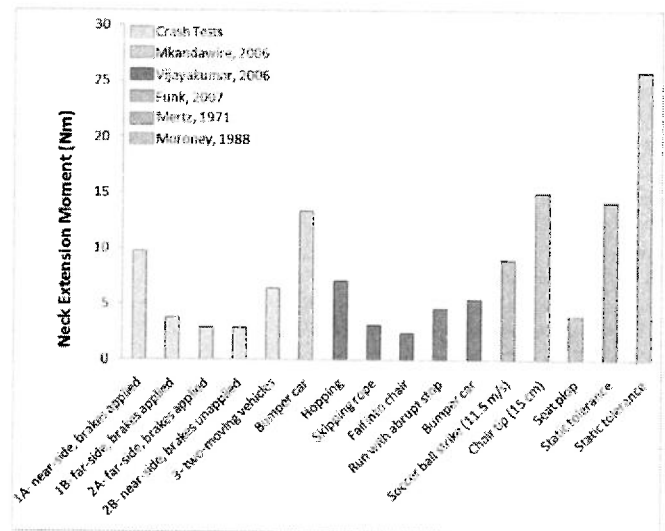
Figure 13. Peak upper neck extension moments for crash testing and various non-injurious activities.

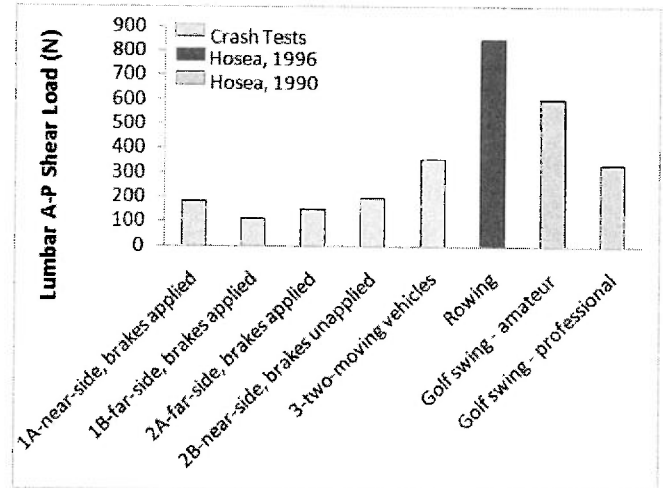
Figure 14. Peak lumbar shear loads for crash testing and various non-injurious activities.

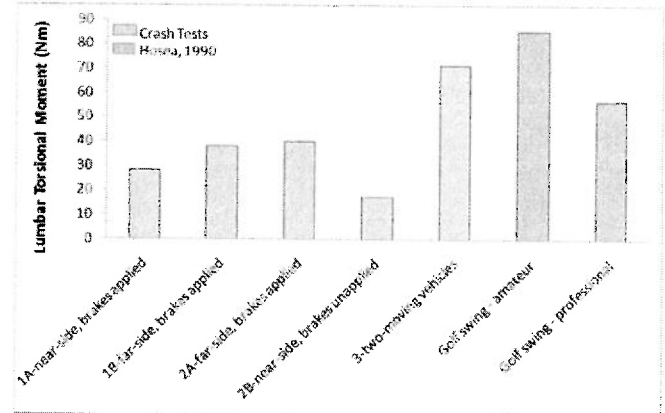
Figure 15. Peak lumbar torsional moment for crash testing and golfing.

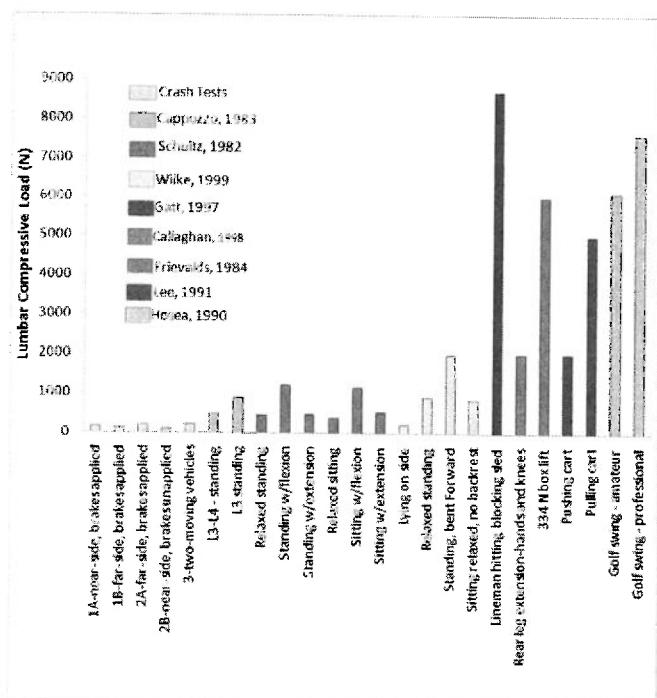
Figure 16. Peak lumbar compressive load for crash testing and various non-injurious activities.

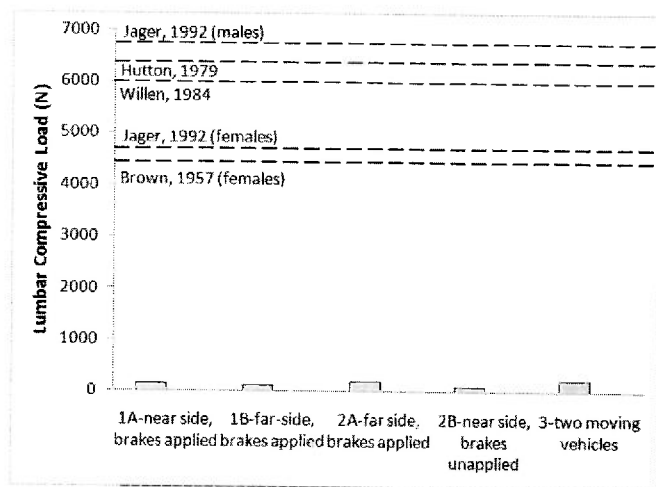
Figure 17. Peak lumbar compressive loads for crash testing in relation to reported lower limits for lumbar failure.

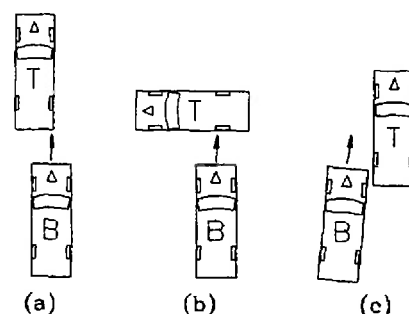
Figure 1. (a) rear and front-end; (b) lateral; (c) side-swipe
For any of the four types of collisions, the usual
